**REPORT OF
ASBESTOS AND LEAD-BASED PAINT
SURVEY AND ANALYSIS
ALDREDGE HEALTH CENTER
Butler Street
Atlanta, Fulton County, Georgia**

WILLMER ENGINEERING INC.
WEI Project No. ATL-175-1531

February 16, 1998

SUBJECT: Report of Asbestos and Lead-Based Paint Survey and Analysis
Aldredge Health Center
199 Butler Street
Atlanta, Fulton County, Georgia 30303
WEI Project No. ATL-175-1531

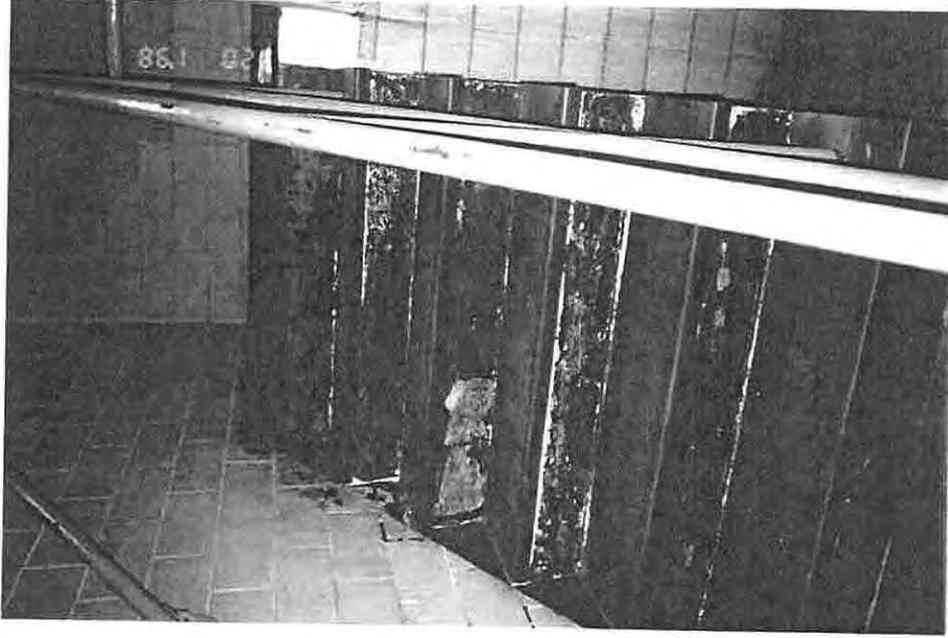
Photograph 12 - Stairwell, Adhesive/Mastic Remnant Door 110, Ground to 1st Floor

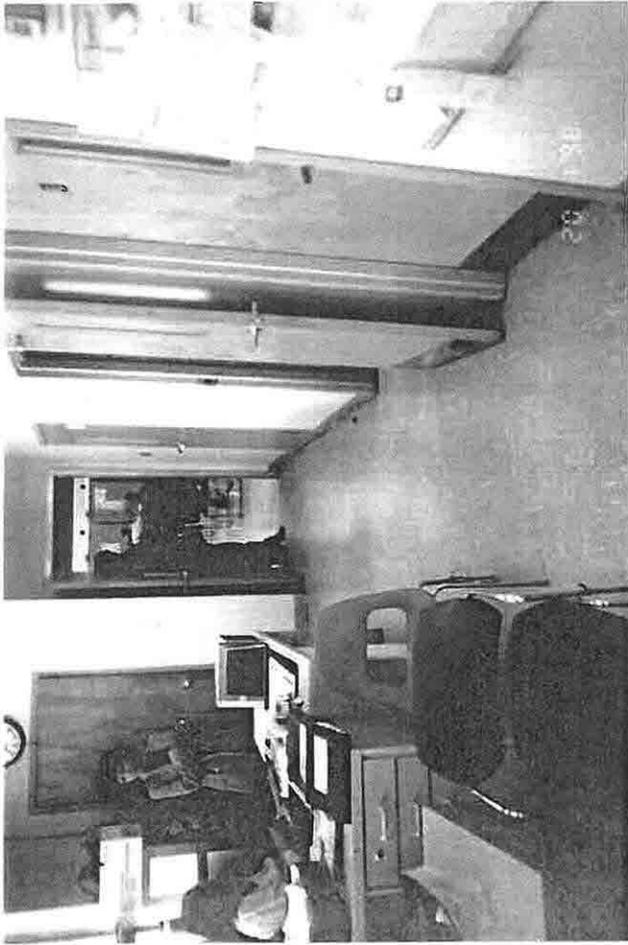
Photograph 4 - 2nd Floor, Room 234.11 - 12" x 12" Beige Floor Tile, Grey 12" x 12" in Cubicles

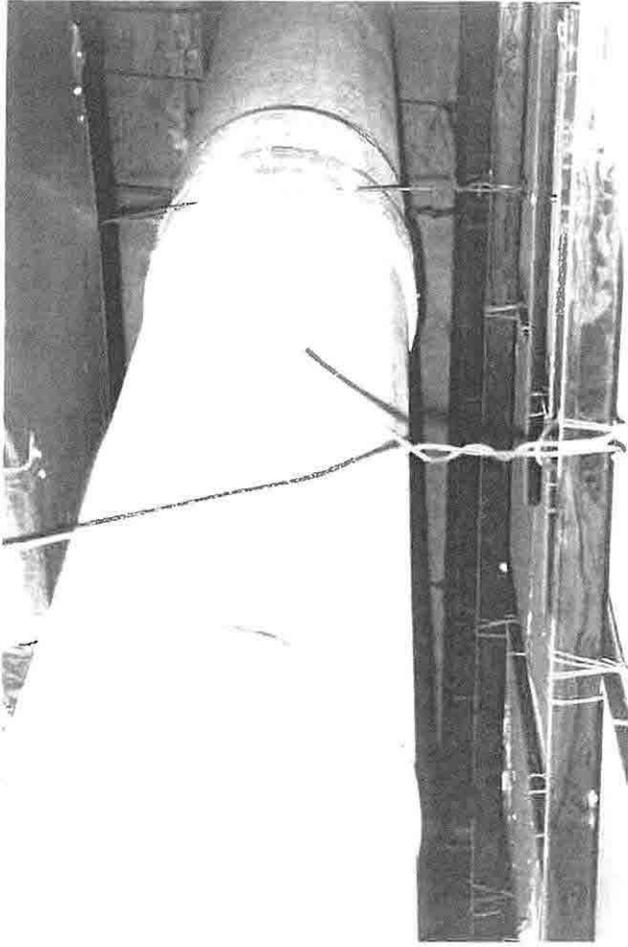
Photograph 5 - Room 234.0, Transite Vent Pipe for Lab Hood Above Ceiling

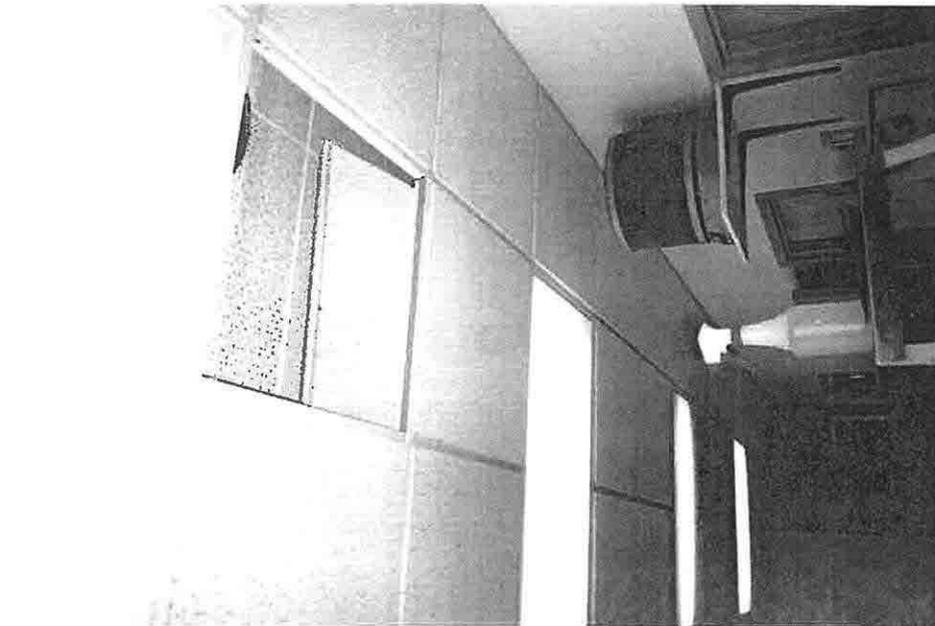
Photograph 8 - 2nd Floor, 1'x1' Ceiling Tile Adhered to Plaster on Wallboard Material Above

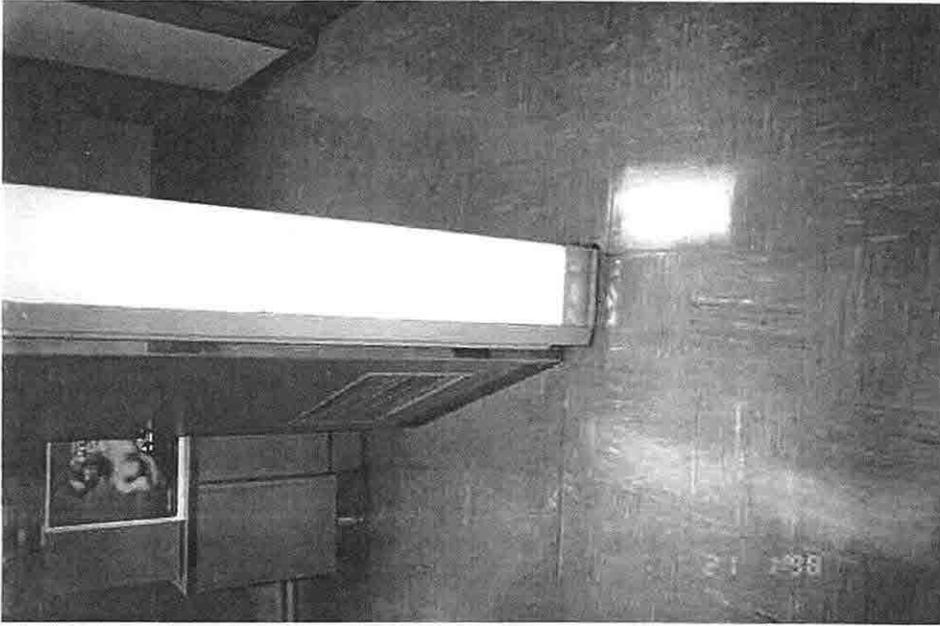
Photograph 9 - Hallway Viewing West, 2nd Floor, Room 241B With 9'x9' Floor Tiles to Left

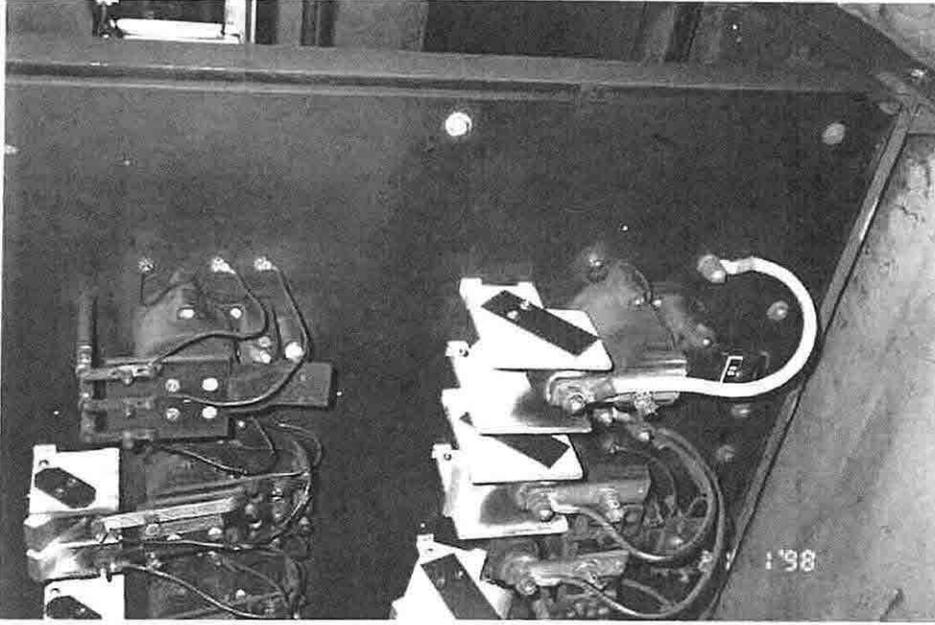
Photograph 10 - Penthouse Elevator Electrical Room Transit Switch Plate and Wire Insulation

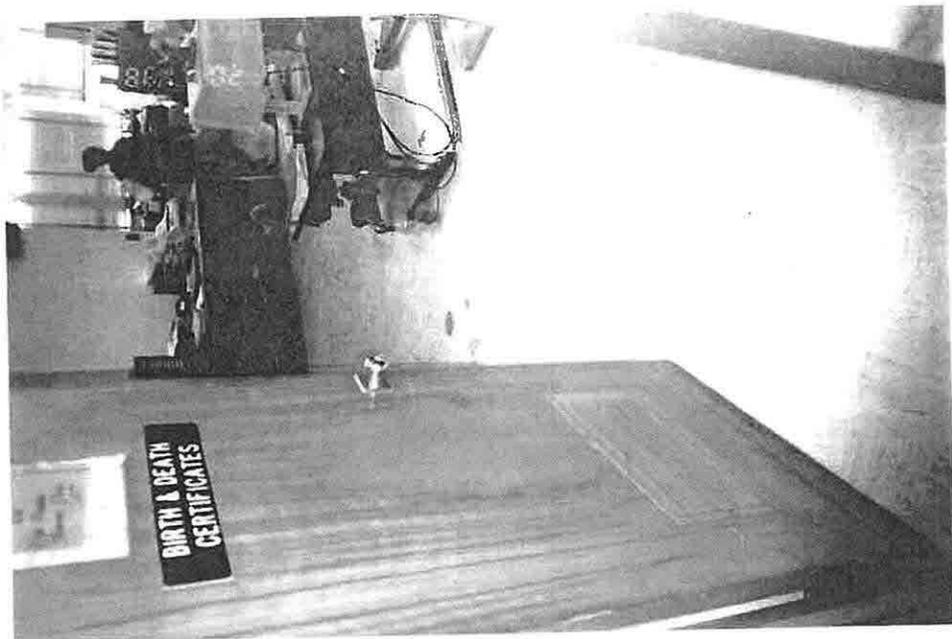
Photograph 3 - 2nd Floor, Room 200 - Two Different 9"x9" Floor Tiles

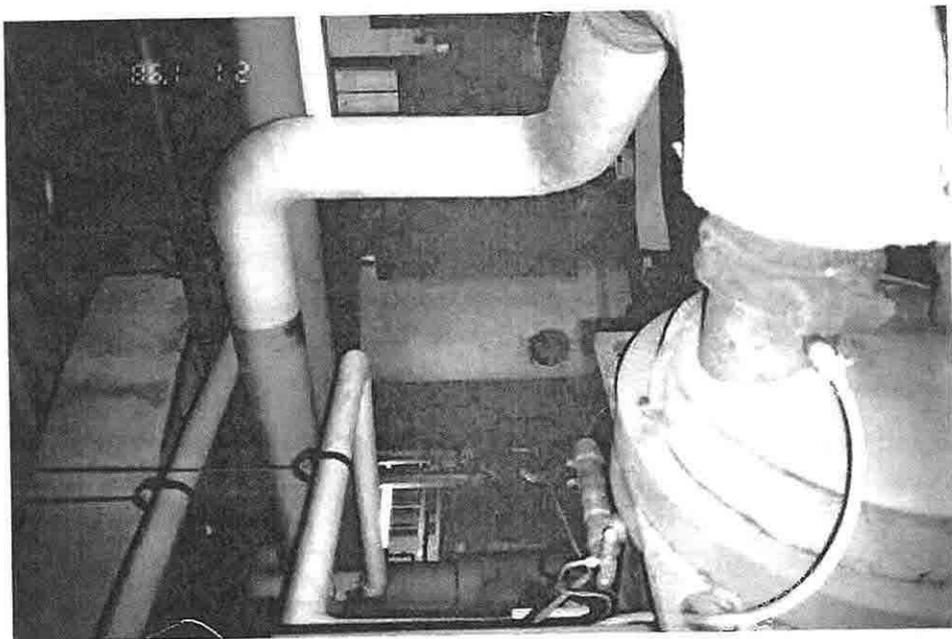
Photograph 2 - Room 105, Hot Water Heater

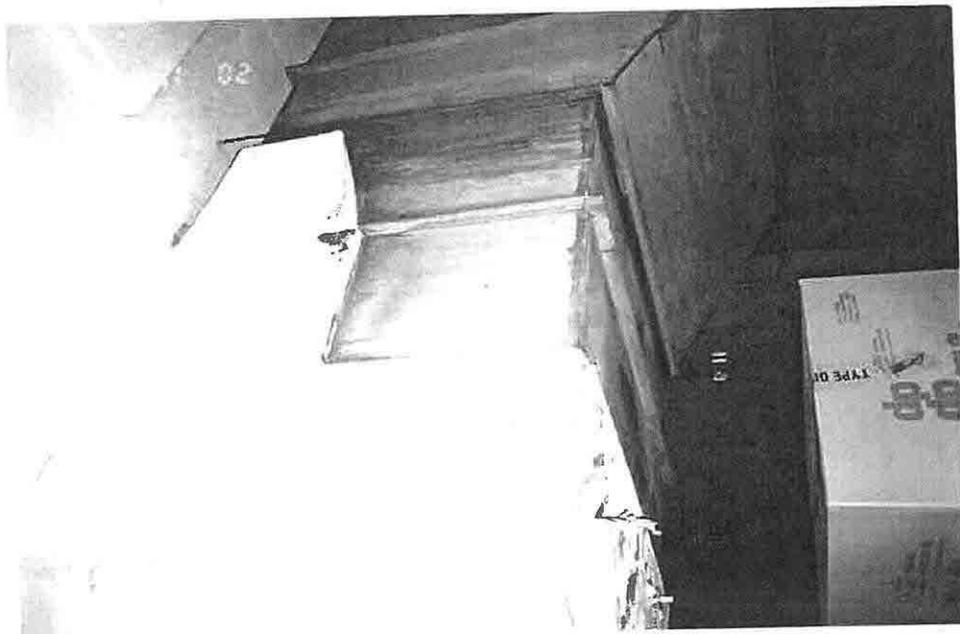
Photograph 1 - Room 105, Mechanical Room - Public Building Maintenance, Air Handler Insulation, Viewing Northeast
